Exhibit 14

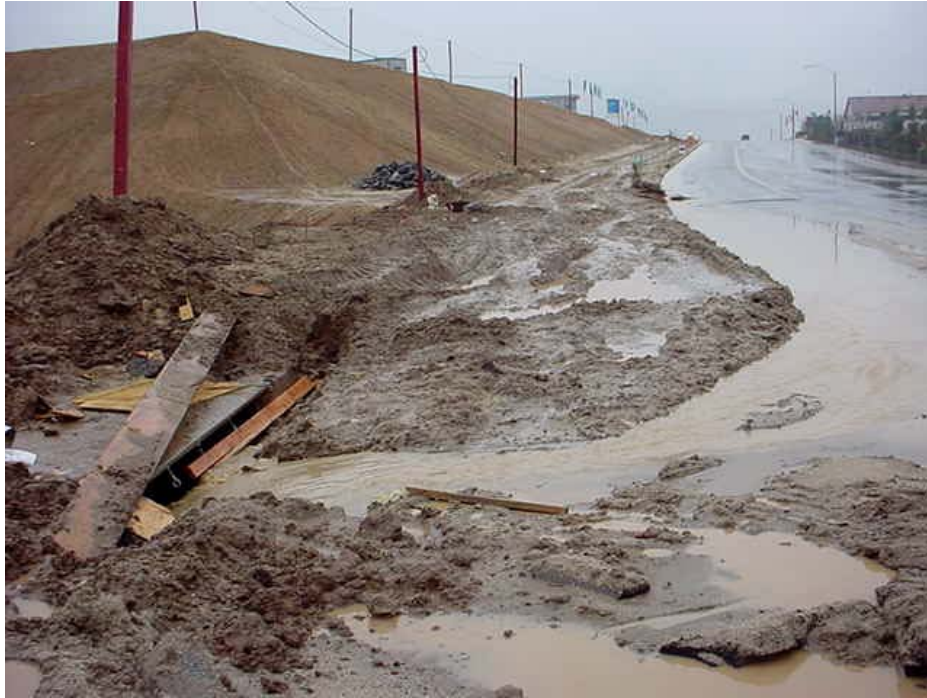
Photograph MVC-025S.JPG taken from the east side of Jackson Avenue looking south depicts the discharge of sediment laden storm water from the Serenada site and entering the City of Murrieta's storm drain inlet. Note the lack of good housekeeping practices, the lack of site perimeter control BMPs, and the lack of storm drain inlet protection.

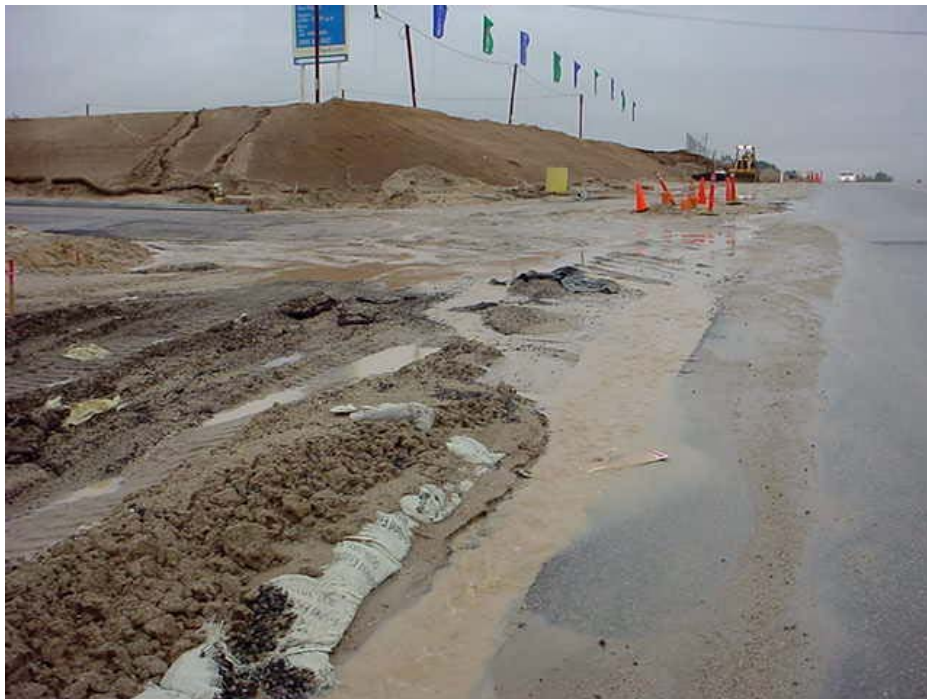
Photograph MVC-027S.JPG taken from the intersection of Nutmeg Street and Jackson Avenue, looking east down Nutmeg Street. Note the slope erosion, lack of site perimeter BMPs, failure to maintain gravel bags, and failure to implement sediment control BMPs in the streets.

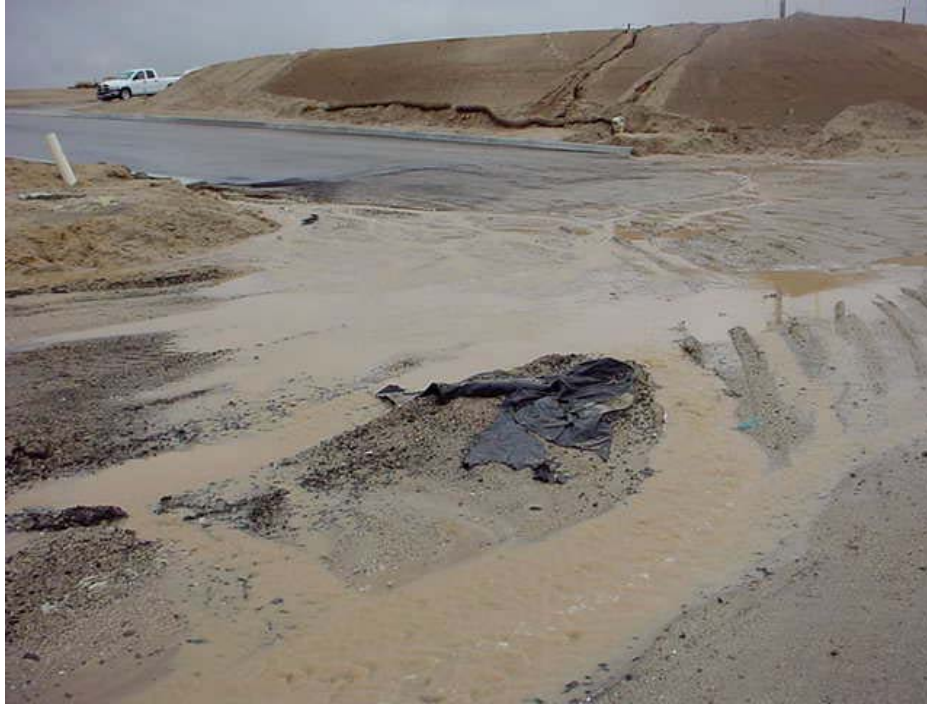
Photograph MVC-028S.JPG taken from the intersection of Nutmeg Street and Jackson Avenue, looking to the northeast along Jackson Avenue. Note the slope erosion, lack of site perimeter BMPs, failure to maintain gravel bags, and failure to implement sediment control BMPs in the streets.

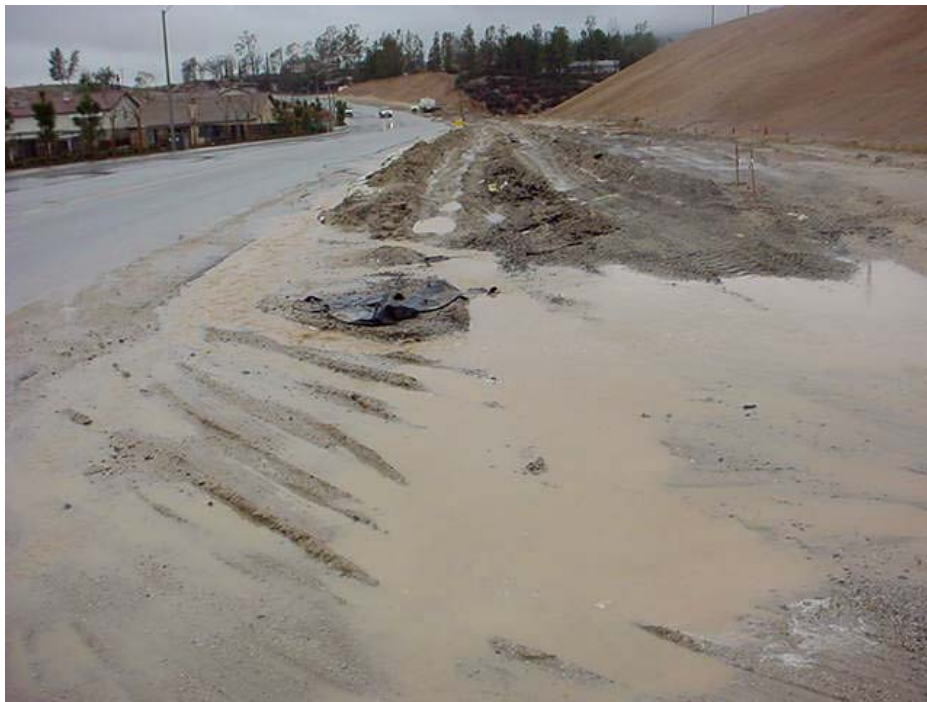
Photograph MVC-029S.JPG taken from the intersection of Nutmeg Street and Jackson Avenue, looking to the west along Nutmeg Street. Note the lack of site perimeter BMPs, failure to maintain gravel bags, and failure to implement sediment control BMPs in the streets.
